MOUNT AIRY DAM

NDS I.D. NO. PA 00811  
DER I.D. NO 45-243

⑥ PHASE I INSPECTION REPORT  
NATIONAL DAM INSPECTION PROGRAM

WOODWARD-CLYDE CONSULTANTS ✓  
5120 Butler Pike  
Plymouth Meeting, Pennsylvania 19462

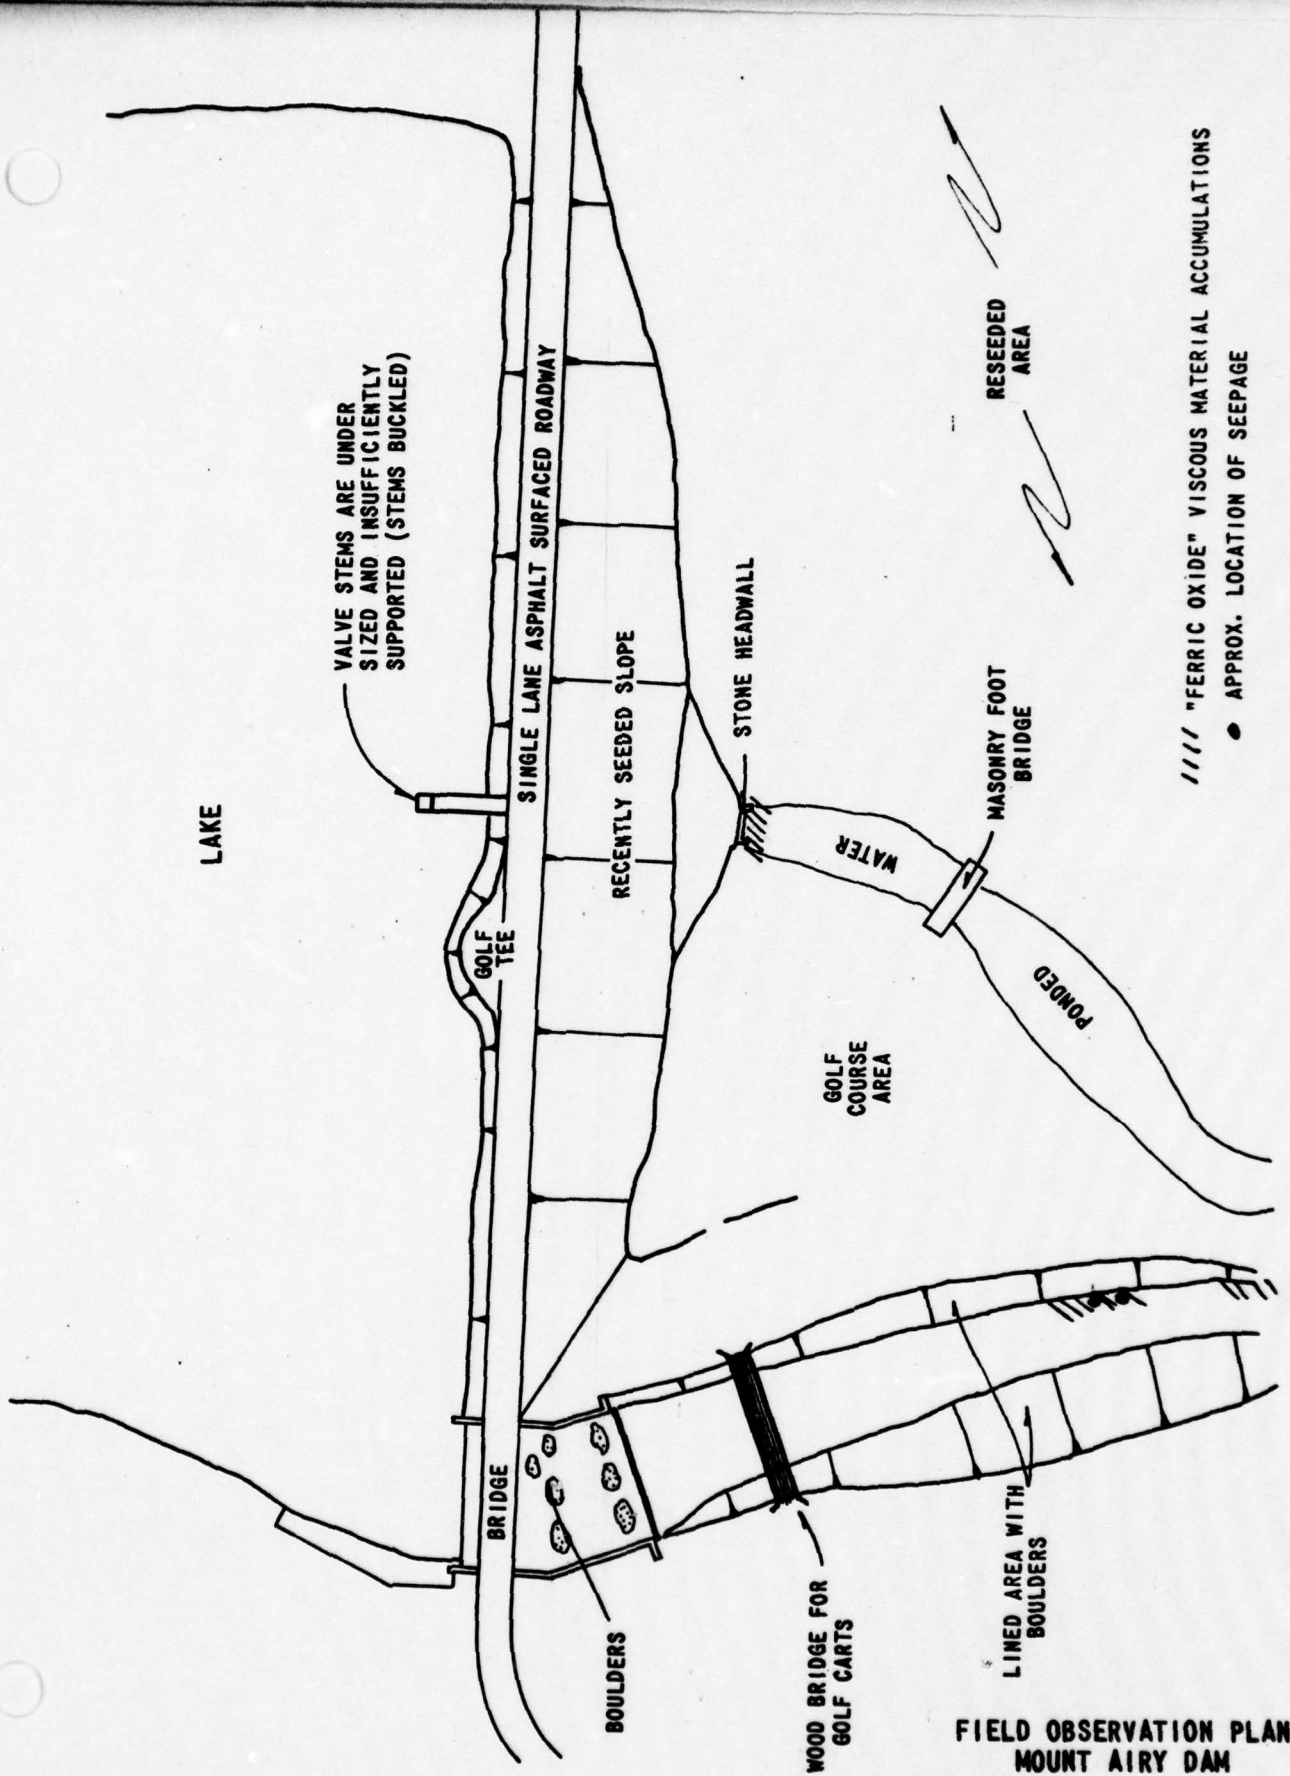
SHEET 5a OF 11

*Could not see embankment drainage system as they outletted through the wing walls of the outlet structure which since has been buried, see next sheet.*

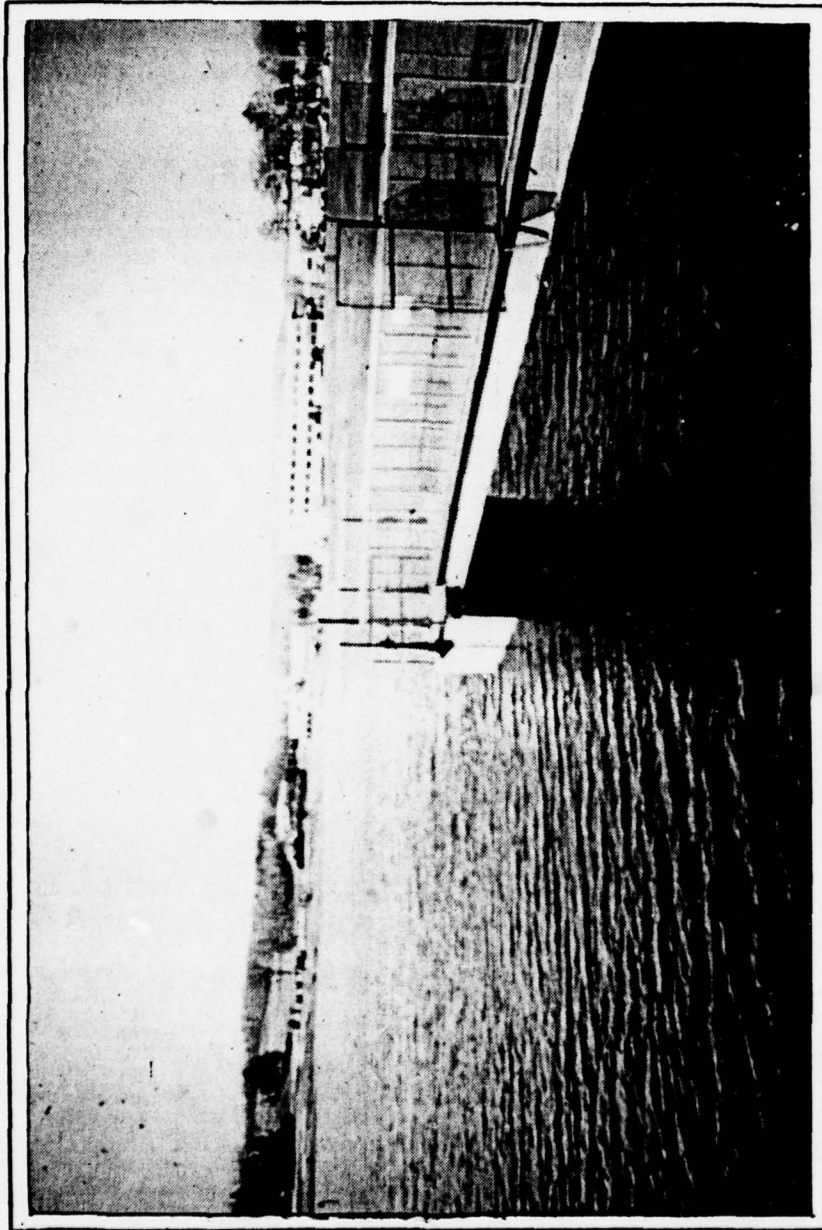
PHOTOGRAPH NO. 1

Exposed portions of the spillway were inspected and judged to be in good condition. The intake tower was also inspected and observed to be in good condition with the exception of the sluice gate stems, which appeared to be undersized and/or insufficiently supported.

As previously mentioned, the intake tower was inspected and the only significant deficiency observed was the sluice gate stems. These stems have buckled and are in poor condition.

VIEW OF INTAKE TOWER AND FOOT BRIDGE  
CONNECTING DAM CREST TO THE TOWER.

1. The mechanical operation of the sluice gate should be checked by a professional engineer and appropriate remedial action taken to correct deficiencies in the sluice gate stems.
2. Appropriate measures should be taken to clear debris clogging the pond drain gate in the event that it is necessary to drain the reservoir.

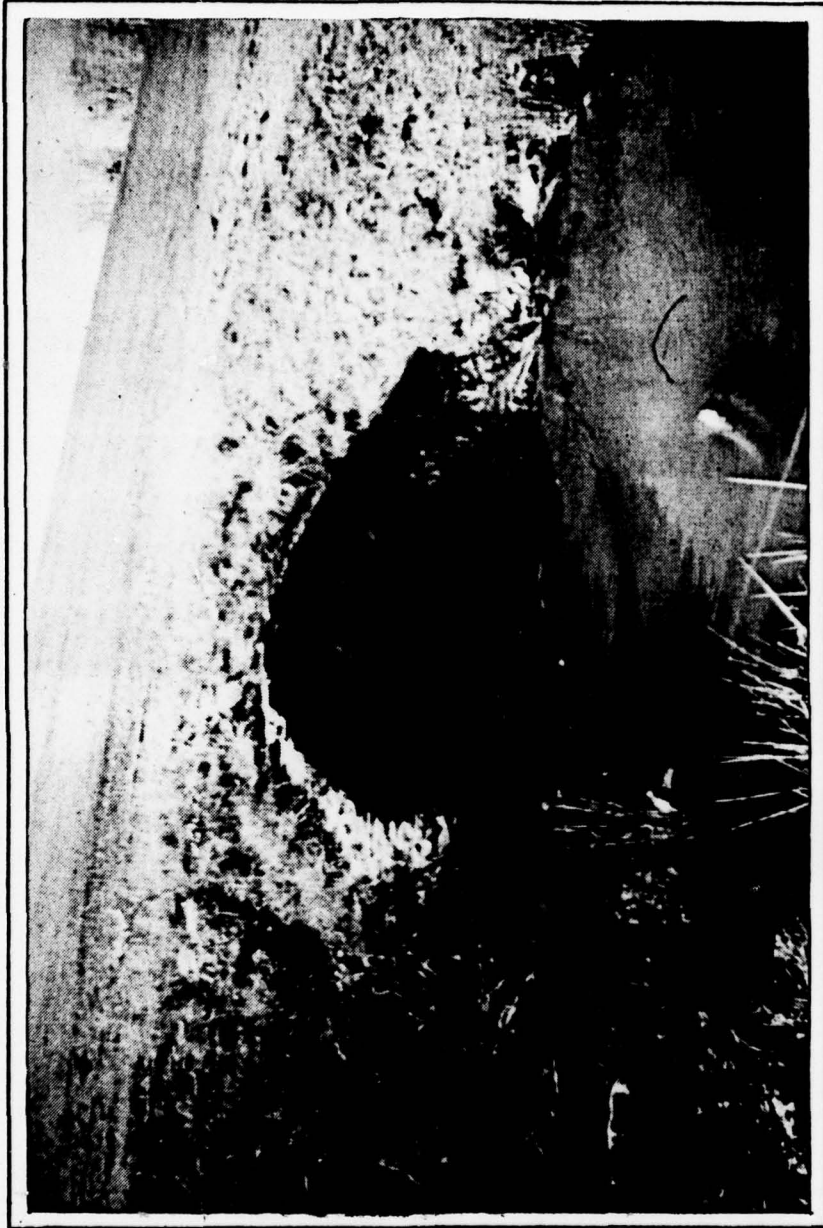
The drawings indicate that a toe drain outlets through the wing walls of the 36-inch pipe outlet structure. The headwall of the structure and the toe drain pipes were constructed; but shortly thereafter, the discharge pipe was extended ten feet with a corrugated metal pipe and a rock headwall was constructed. Seepage collected by the toe drain is discharged through this pipe, combining with the sluice gate discharge from the tower. Therefore, the seepage rates from the embankment drains could not be estimated. Ferric oxide stained material was also noted at the outlet.

There was no visible seepage through the downstream toe. Some clear seepage was noted beyond the water hazard pond and this seepage should be investigated to determine its source and affect on the dam. The toe drain outlets could not be inspected as they discharge inside the discharge pipe.

DISCHARGE CONDUIT AT TOE OF DAM.  
INTAKE TOWER INFLOW DISCHARGES  
THROUGH THIS CONDUIT.

3. The toe drain discharge pipes should be inspected to confirm that they are functioning as designed.
4. The embankment crest and right abutment should be raised to an elevation at least equal to the top of the bridge deck.
5. Erosion on the downstream slope should be monitored and corrective action taken as necessary.
6. The leakage noted through the wall of the intake tower should be repaired during the normal annual maintenance of the structure.
7. The upstream riprap should be monitored for continued settlement and, if settlement continues, necessary remedial measures should be taken.

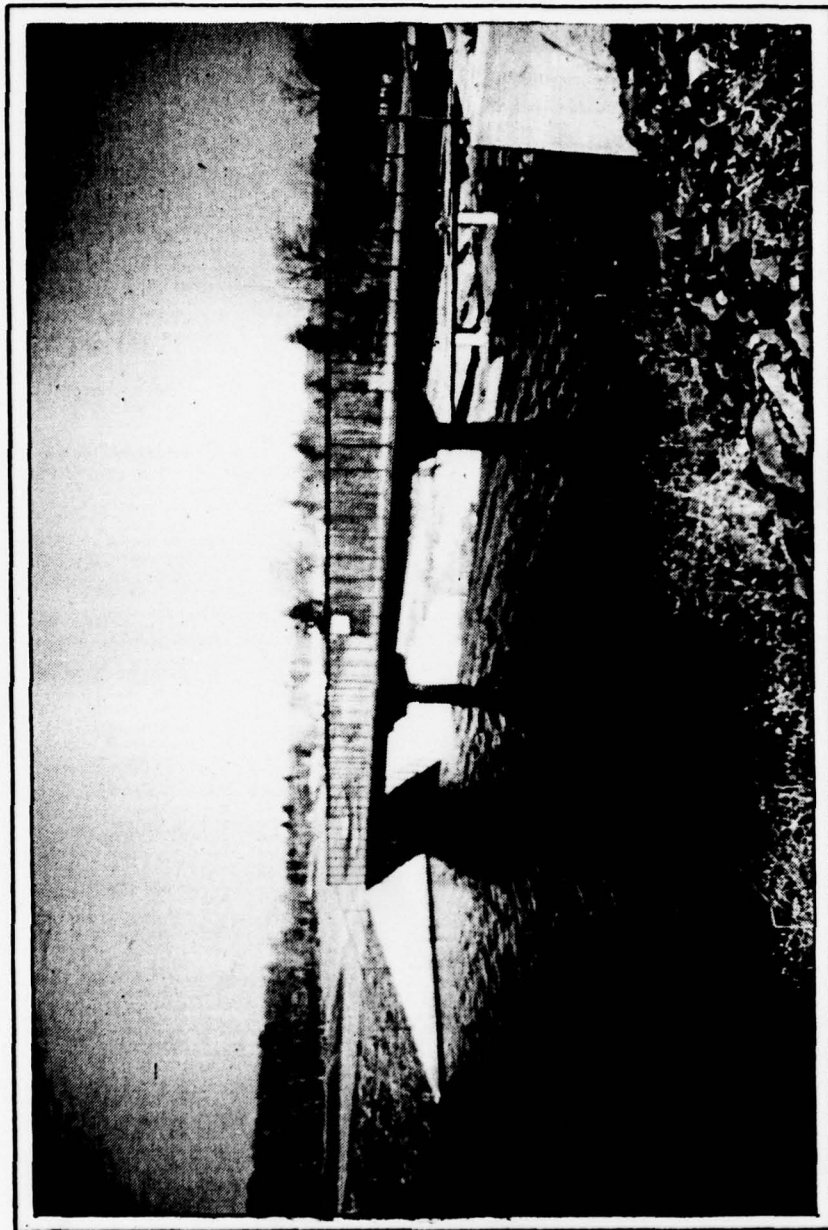
PHOTOGRAPH NO. 4

OVERVIEW FROM RIGHT ABUTMENT LOOKING  
AT APPROACH CHANNEL TO EMERGENCY  
SPILLWAY.

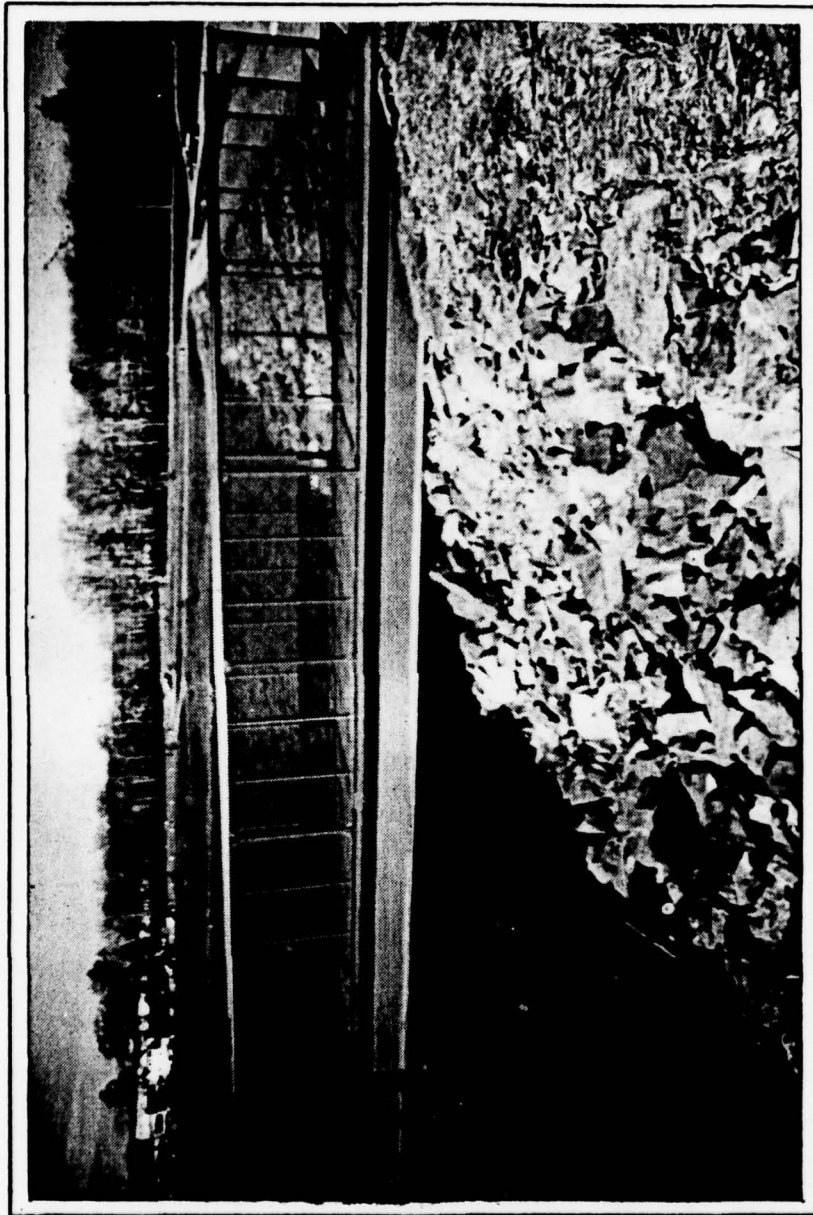
PHOTOGRAPH NO. 7

The upstream riprap surface undulated showing signs of slight erosion. The quality of the rock was assessed to be very good. No indications of surface cracks were noted on the embankment crest or on the slopes. Some minor erosion was noted on the downstream slope. However, the slope had recently been seeded and the grass was not yet established.

RIPRAP FAILURES	The upstream riprap slope undulates with signs of erosion probably due to settlement and/or wave action. This condition should be monitored and corrected as necessary to minimize degradation of the slope.	
-----------------	---	--

VIEW OF UPSTREAM RIPRAP LOOKING  
TOWARDS LEFT ABUTMENT.

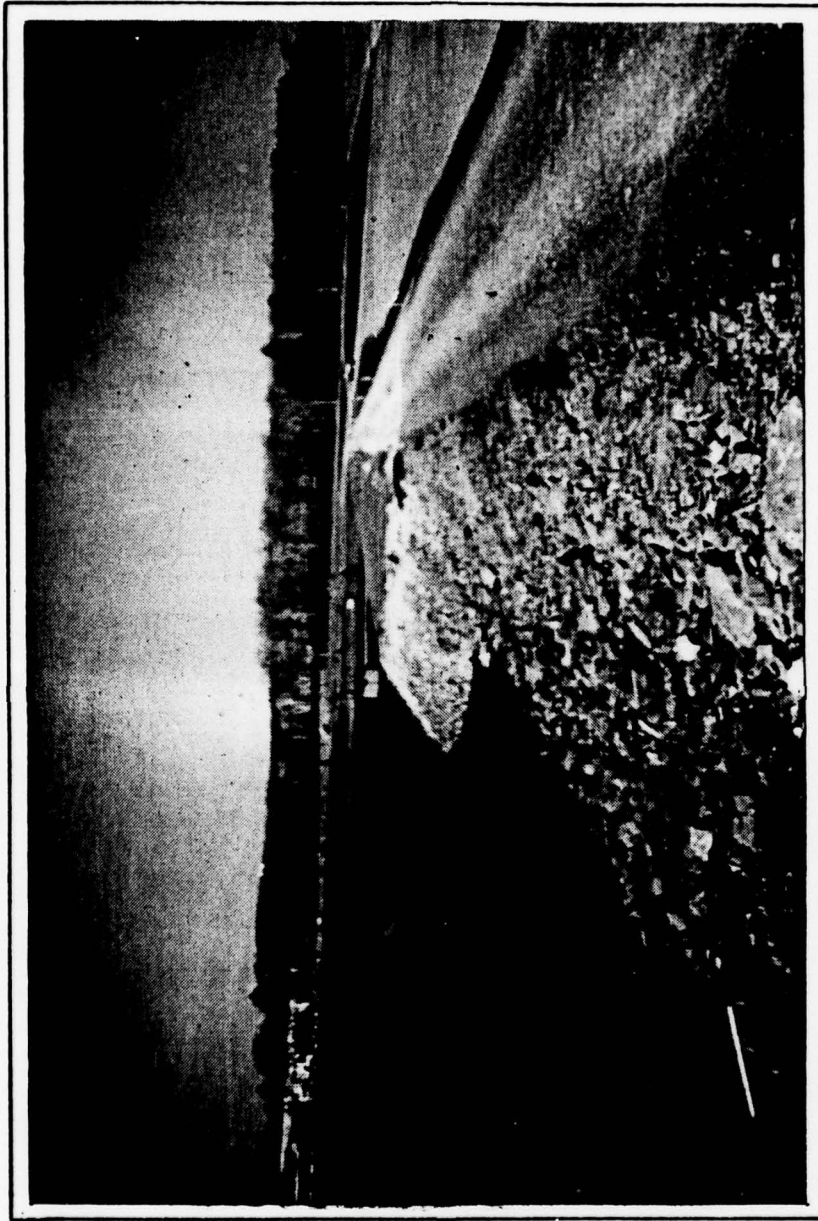
PHOTOGRAPH NO. 8

b. Dam. During the visual inspection, there were no indications of distortion in alignment or grade that would be indicative of excessive movement of the embankment or foundation. Minor settlement of the embankment was noted adjacent to the left wall of the spillway. A profile along the dam crest indicates a low point (about six inches) some 20 feet left of the spillway. Also, the right abutment has a swale that is about ten inches lower than the top of the bridge deck.

VIEW OF DAM CREST LOOKING FROM  
EMERGENCY SPILLWAY TOWARDS LEFT  
ABUTMENT. BULGE IN UPSTREAM  
SLOPE IS A GOLF TEE.
